Analysis of Engine Piston Damage to the Generator Set Using the Fishbone Analysis Method

Abstract. The generator set unit operating at PLTD Leung Bata-Aceh suffered damage to the piston component, which initially indicated thick white smoke coming out of the breather. The purpose of this study was to determine the root cause of piston damage. The method in this study using fishbone analysis. Based on the research results, the damage to the piston top was caused by the imperfect angle of the injector, so that the injector spray widened on the outer side of the piston crown top, causing the piston surface to be damaged on the edge. Corrective steps so that the same incident does not occur again, the injectors must be tested before use, they must be tested, to determine the performance of the injectors used.

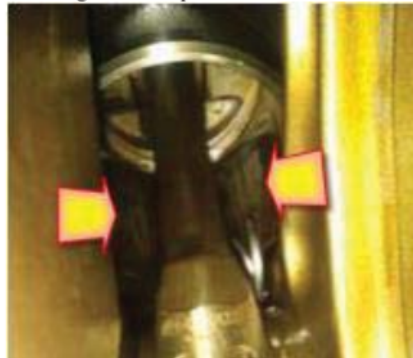
In Figure 1, the liner wall flows scratches caused by friction with the piston that is damaged. Scratches that occur cause the liner not to be used again and the damage to the liner is the result, not the cause. Figure 1 scratch on the inner liner was found during a fault investigation component.

FIGURE 1. Fuel leakage from the liner and piston.

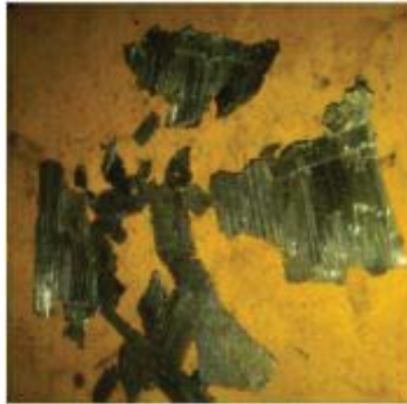
Whereas Figure 2 shows the piston debris attached to the liner wall, discovered during a fault investigation of the generator set. The piston material attached to the liner wall is caused by the piston working at high temperatures. The piston moves in the process of experiencing stress, temperature, pressure which often occurs due to thermal and mechanical fatigue [6]. Figure 2 piston material debris was found during the investigation.

FIGURE 2. Flakes of piston material.

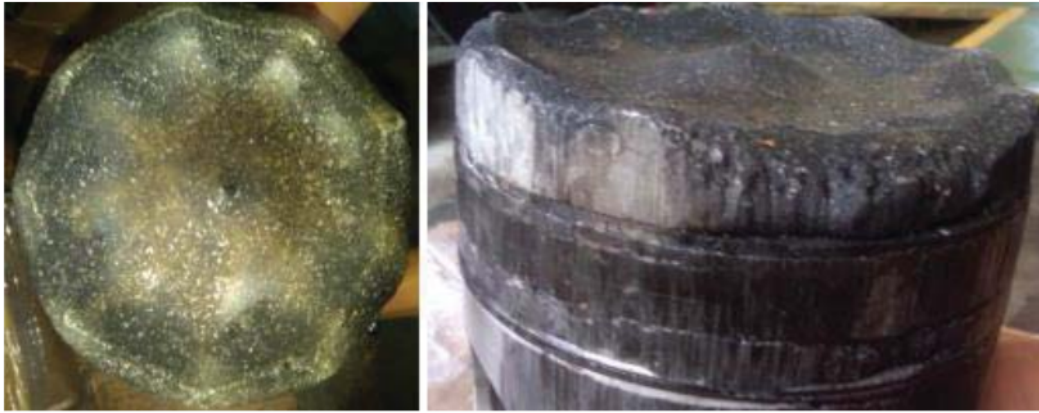
The shape of the piston crown top is irregular because the angle of spraying the injector is not normal [8], this is known to be the shape of the corrugated piston crown top. When the piston material melts it closes the ring groove causing the piston ring to stack and contact with the liner [9].

Damage to piston skirt #12 experienced the same as piston # 5. Self-explanatory on the top crown the piston spray injector is abnormal. If this is left for a long time then the condition of the #12 piston will have a shape similar to that of cylinder #5 [5].

FIGURE 4. Top melting piston crown on cylinder # 12.

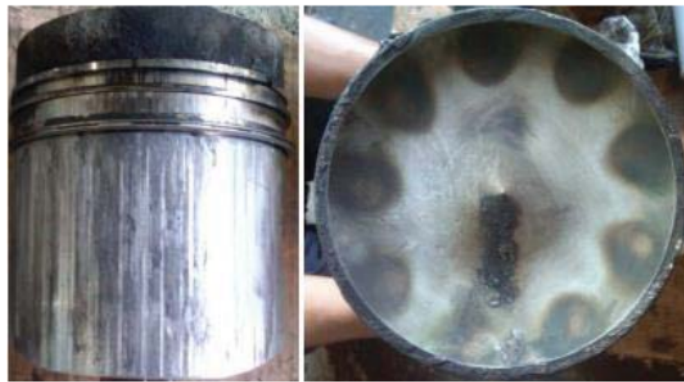
In Figure 5, it is explained that the high scratches piston wall where the piston works at high temperature so that the piston wall is melting and the town crown piston is indicated as a black discoloration on the side that gets the spray from the injector (right photo), ash on the town crown piston is caused by the abnormal angle at the injector [10]. Changes in the thermal expansion coefficient for the alloy in the raw state and after heat treatment and the piston made of the new composite material before the motor test and after this test [11]. As for the piston components that are used using aluminum, it is adjusted to the diesel engine serial number from the manufacturer.

FIGURE 5. Spray injector on piston-cylinder #5

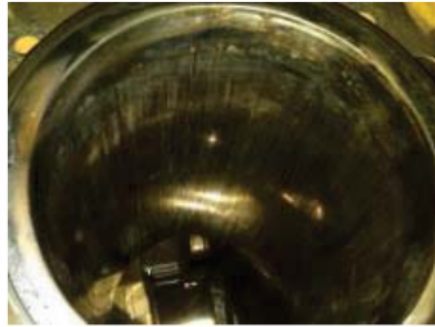
Heavy scratches on the liner wall is due to the tow crown piston melting and closing the piston ring seat so that it contacts with the liner (scuffing). Measurement of the secondary motion of each piston was carried out to analyze piston friction, and the following findings were obtained. Cast iron pistons exhibit limited lubrication at die center over-compression (TDC). This is probably due to the larger piston tilt angle due to the greater piston clearance. Steel pistons exhibit hydrodynamic lubrication conditions at TDC and BDC through each cycle, due to good oil supply [12].

FIGURE 6. Wall liners high scratches

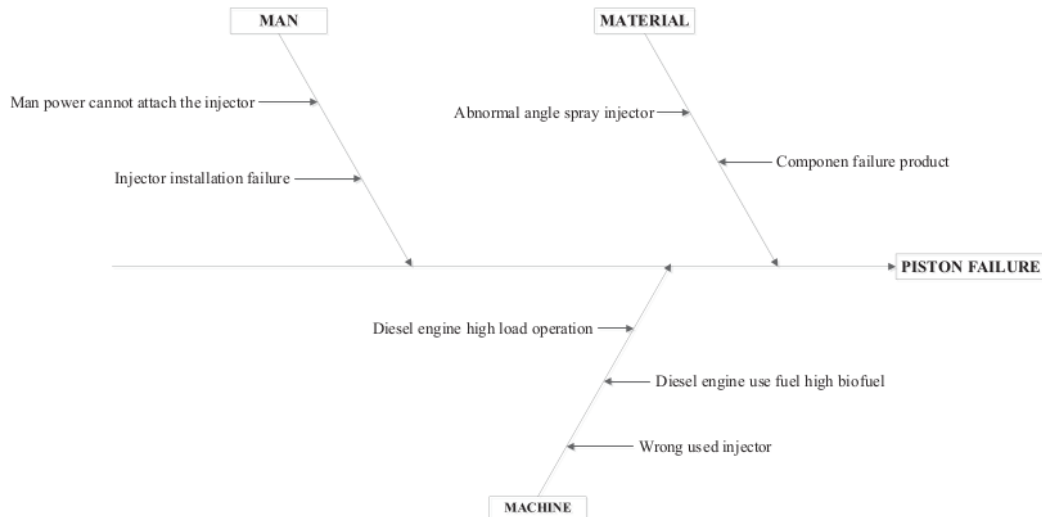
FIGURE 7. Fishbone analysis

At the time of installing the injector, the technician failed to install it, and the tip of the injector collided with the engine component. Then it was wrongly installed, where this condition was caused by the knowledge of the technician who did not understand the injector installation process.

Angle spray injector is damaged due to the design of the manufacturer because it does not match the engine type or product failure.

Piston damage caused by high operating load or overload is not identified for piston damage, then the damage caused by fuel containing biodiesel is not indicated. Meanwhile, the error in using the injector is not indicated [7]. The delay in the execution of the engine overhaul will affect the performance of engine components. In determining the unit's overhaul work there is no maintenance strategy, so the overhaul work is based on the unit's condition.

Trending in addition to 150 liters of engine oil starting high school: 2,784-2,922, during the unit operating 138 hours, at the hour meter 2,922 a blowby occurred in the operating unit, where the damage was caused by damage to the piston components. Based on the fishbone analysis, the damage was caused by an abnormality in the angle of the injector.
