Analysis of Water Contaminated Engine Oil in Engine Generator Set

This case study was conducted in a manufacturing company that experienced a breakdown in a power generator set. A standard investigation was carried out by opening the crankcase cover and checking the dipstick. The results of the visual inspection showed that the engine oil was contaminated with water. Therefore, this study was conducted to further analyze the causes of oil contaminated with water in the unit being handled using fault tree analysis (FTA). As a result, cracks were found in the cylinder liner due to pitting on the outer liner with a pitting depth of more than 2 mm. In our analysis, pitting is formed due to the presence of air bubbles in the cooling system. Based on FTA, the formation of air bubbles is caused by the quality of the coolant. We also found that the coolant used was not added with any additives.

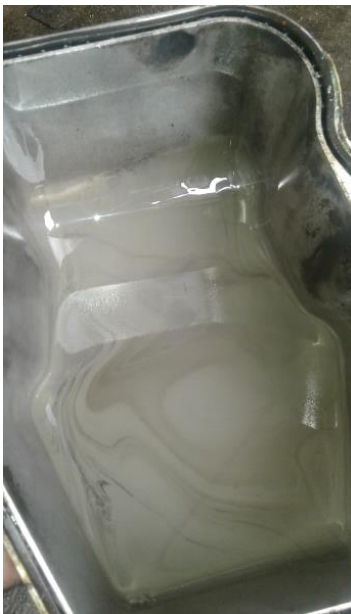
In Figure 1, it was found that oil mixed with radiator water, so that the radiator water turned the color into coffee milk. If these conditions are found, the steps that must be taken are to stop the unit and drain oil, then clean using diesel. So that the oil mixed with the coolant is clean and does not damage other components. If the oil is contaminated with water, the function of the oil is not optimal [4], where the oil will change color and affect the lubrication system of the diesel engine. If left for a long time, it will have a considerable impact on all engine components, such as cylinder liners, pistons, cylinder heads, rocker arms, connecting rods, and other spare parts in engine components.

Figure 1.
Engine oil
contaminated
with water

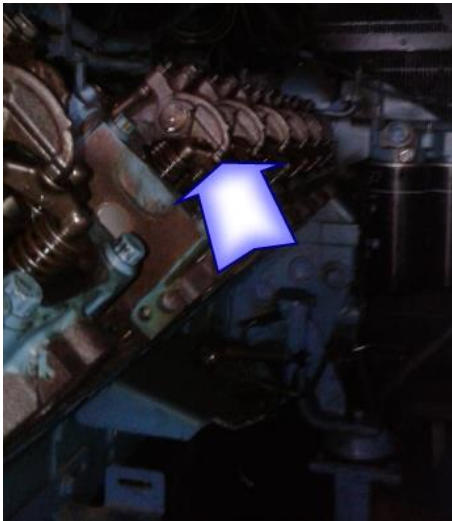
In [Figure 3](#) the rocker arm is rusty caused by condensation when the engine oil is contaminated with water. The steam from inside the crankcase goes to the rocker arm, then the steam flows to the breather. Rust on this engine component if not cleaned immediately, will damage other components.

As described in [Figure 3](#) rust on the surface of the rocker arm intake and exhaust caused by water vapor from the oil pan, this rocker arm as a result, not a cause. It is recommended that if rocker arm rust is found due to moisture, it should be cleaned immediately with clean oil (new oil), so as not to harm other components.

Figure 3. Rocker arm rust

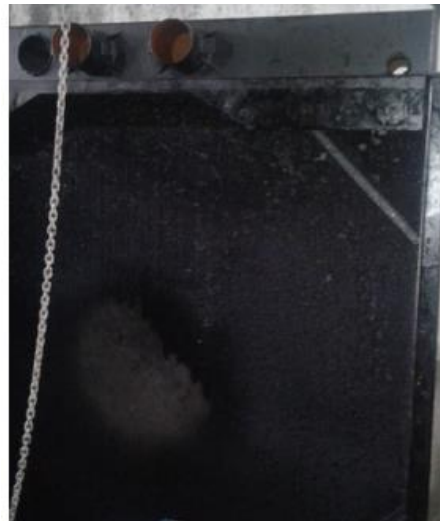
The condition of the radiator on the unit, contaminated with dust, etc., will have an impact on the engine cooling system. This can have an impact on the cooling water circulation system that is not optimal [9], causing the radiator water temperature to increase and can cause overheating [10]. Recommendations for blocked radiator conditions, so that routine maintenance is carried out every 3 months. And when cleaning the radiator, In Figure 4 the condition of the radiator is covered by dust contamination which causes the radiator to be blocked.

Figure 4. Radiator blocked

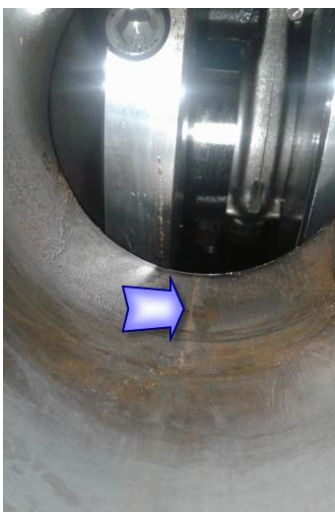
While the surface of the inner liner wall has an indication of rust, which is due to the radiator water being in the combustion chamber, which is described in Figure 5. After identification of the engine oil being contaminated with water, a crack was found in one of the cylinder liner cracks at the bottom of the cylinder liner [11].

Figure 5. Cylinder crack

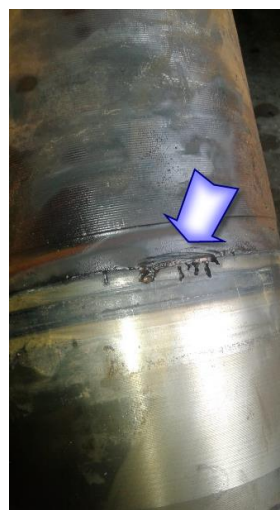
At the time of dismantling the liner, the outer liner wall was found, pitting was found in the bad filler area and the other outer walls, the pitting depth was more than 2 mm (see Figure 6). With the finding of pitting occurring on the outer liner wall [12], the beginning of the cracking of the liner wall. The pitting is formed due to the presence of air bubbles in the cooling system. Air bubbles are formed due to radiator water that does not use additives [13].

Figure 6. Pitting

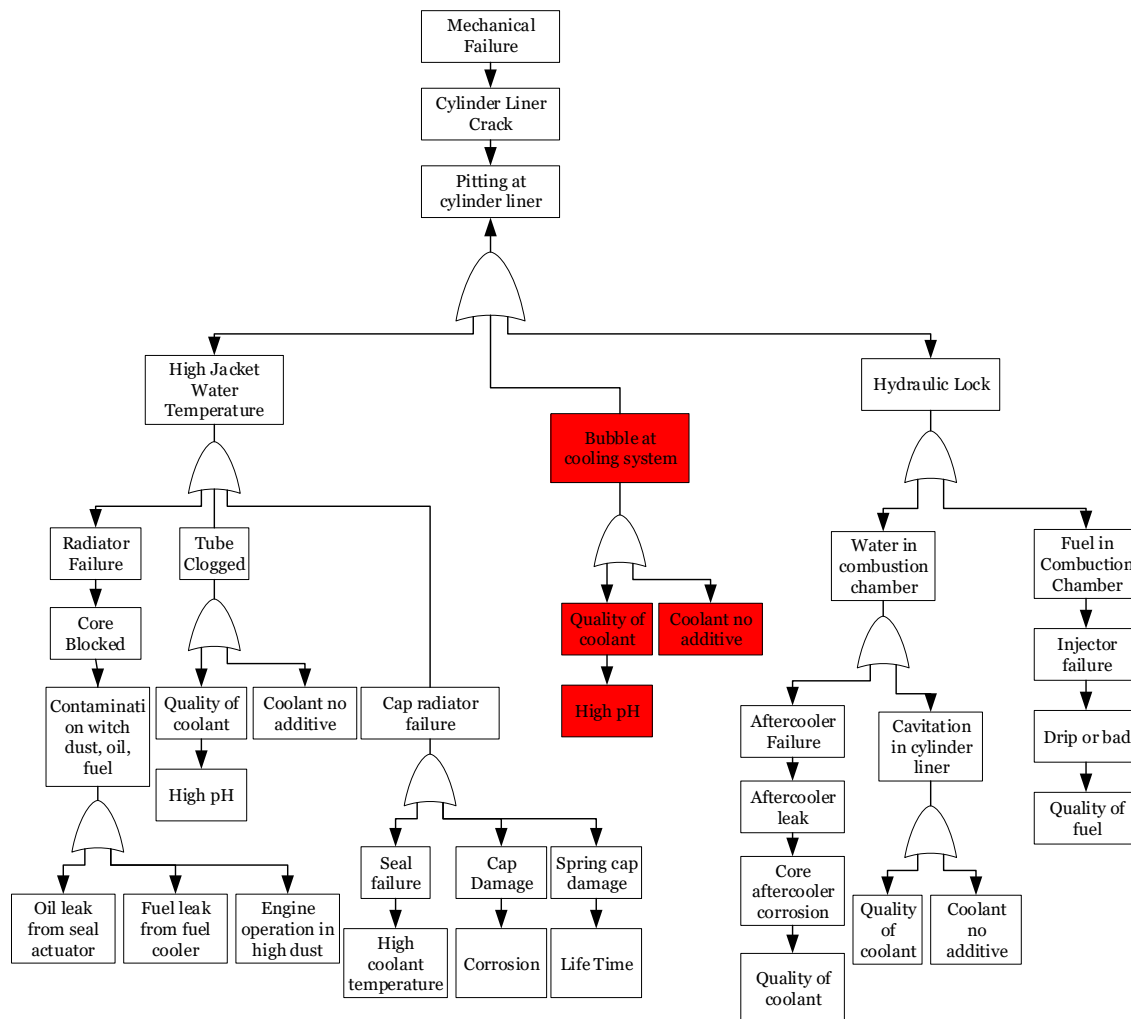
Figure 7. Fault tree analysis

From the analysis carried out using fault tree analysis, several parts cause pitting on the liner resulting in cylinder liner cracking, according to the explanation in [Figure 7](#).

- High radiator water temperature caused by radiator damage, especially radiator core covered with dust, oil, and diesel contamination, so the water flowing through the radiator is hot. Then it has flowed back to the engine in hot conditions, the hot radiator water cannot absorb heat properly, and will cause damage to the components that are fed by the radiator water. As for the contamination of the radiator core against oil leakage caused by damage to the actuator seal, and contamination of dust and diesel, there is damage to the fuel cooler, and the engine operates in an area with high dust.

- Blocked radiator tubes: Silica deposits in the cooling system will affect the heat distribution to the cooling system. If the additive concentration exceeds 60% it will affect the ability of the water as a coolant and will produce silica deposits. This silica deposit will reduce the diameter of the oil cooler tube. Excessive mineral content in water can cause damage to engine components, due to the inhibition of heat transfer[14]. Coolant radiators that do not use additives will affect the boiling point of the coolant and make it easier for air bubbles to form in the cooling system.

- The relationship with high radiator water temperature, as stated in point A (2), is related to damage to the radiator core.
- Broken Radiator Cap [\[7\]\[15\]](#): Leaking water on the radiator cap can cause reduced pressure and coolant, the air in the system will cause bubbles or aeration and will affect the ability of the water pump.

- Radiator water quality that is not per the specifications used, where the excessive mineral content in the water can cause damage to the engine due to inhibited heat transfer [\[16\]](#). In this case, it will affect the boiling point of the radiator water which can cause air bubbles [\[17\]](#).
- Air bubbles bursting at hot spots in the cylinder liner area will result in corrosion wear [\[18\]](#). Air bubbles in the cooling system can form because the radiator water does not use additives [\[19\]\[20\]](#).

The hydraulic lock that occurs is due to the presence of liquid fluid (diesel and water) in the combustion chamber. This event occurs when the unit is on standby (not operating), and when it is about to be operated the engine cannot crank or start, and if forced it will result in broken connecting rods and damage to other engine components.

- Damage to the aftercooler (air cooler) due to corrosion of aftercooler components. Corrosion that occurs is due to the quality of radiator water that does not use additives.
- Pitting on the cylinder liner can result in liquid fluid being in the combustion chamber because the pitting depth is more than 2 mm.

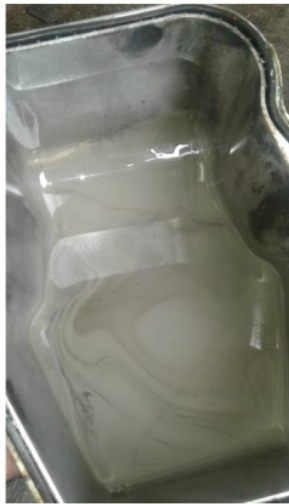
In Figure 1, it was found that oil mixed with radiator water, so that the radiator water turned the color into coffee milk. If these conditions are found, the steps that must be taken are to stop the unit and drain oil, then clean using diesel. So that the oil mixed with the coolant is clean and does not damage other components. If the oil is contaminated with water, the function of the oil is not optimal [4], where the oil will change color and affect the lubrication system of the diesel engine. If left for a long time, it will have a considerable impact on all engine components, such as cylinder liners, pistons, cylinder heads, rocker arms, connecting rods, and other spare parts in engine components.

Figure 1.
Engine oil
contaminated
with water

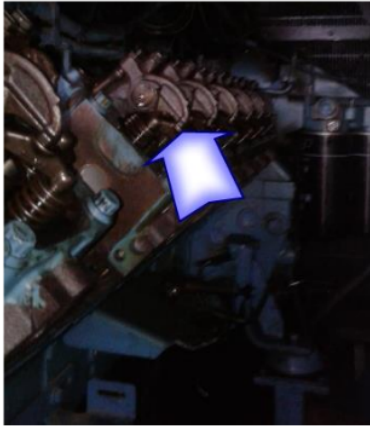
In Figure 3 the rocker arm is rusty caused by condensation when the engine oil is contaminated with water. The steam from inside the crankcase goes to the rocker arm, then the steam flows to the breather. Rust on this engine component if not cleaned immediately, will damage other components.

As described in Figure 3 rust on the surface of the rocker arm intake and exhaust caused by water vapor from the oil pan, this rocker arm as a result, not a cause. It is recommended that if rocker arm rust is found due to moisture, it should be cleaned immediately with clean oil (new oil), so as not to harm other components.

Figure 3. Rocker arm rust

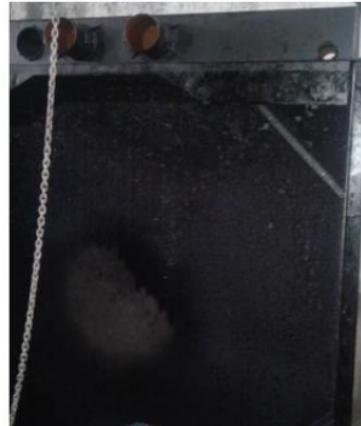
The condition of the radiator on the unit, contaminated with dust, etc., will have an impact on the engine cooling system. This can have an impact on the cooling water circulation system that is not optimal [9], causing the radiator water temperature to increase and can cause overheating [10]. Recommendations for blocked radiator conditions, so that routine maintenance is carried out every 3 months. And when cleaning the radiator, In Figure 4 the condition of the radiator is covered by dust contamination which causes the radiator to be blocked.

Figure 4. Radiator blocked

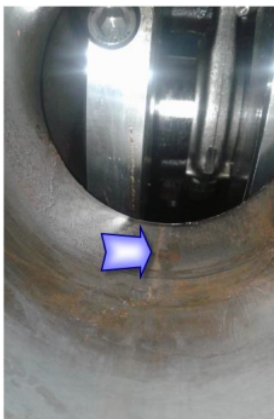
While the surface of the inner liner wall has an indication of rust, which is due to the radiator water being in the combustion chamber, which is described in Figure 5. After identification of the engine oil being contaminated with water, a crack was found in one of the cylinder liner cracks at the bottom of the cylinder liner [11].

Figure 5. Cylinder crack

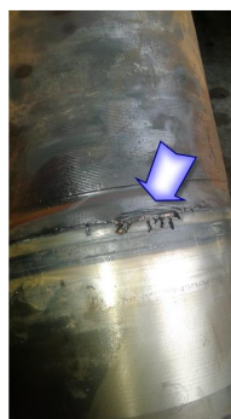
At the time of dismantling the liner, the outer liner wall was found, pitting was found in the bad filler area and the other outer walls, the pitting depth was more than 2 mm (see Figure 6). With the finding of pitting occurring on the outer liner wall [12], the beginning of the cracking of the liner wall. The pitting is formed due to the presence of air bubbles in the cooling system. Air bubbles are formed due to radiator water that does not use additives [13].

Figure 6. Pitting

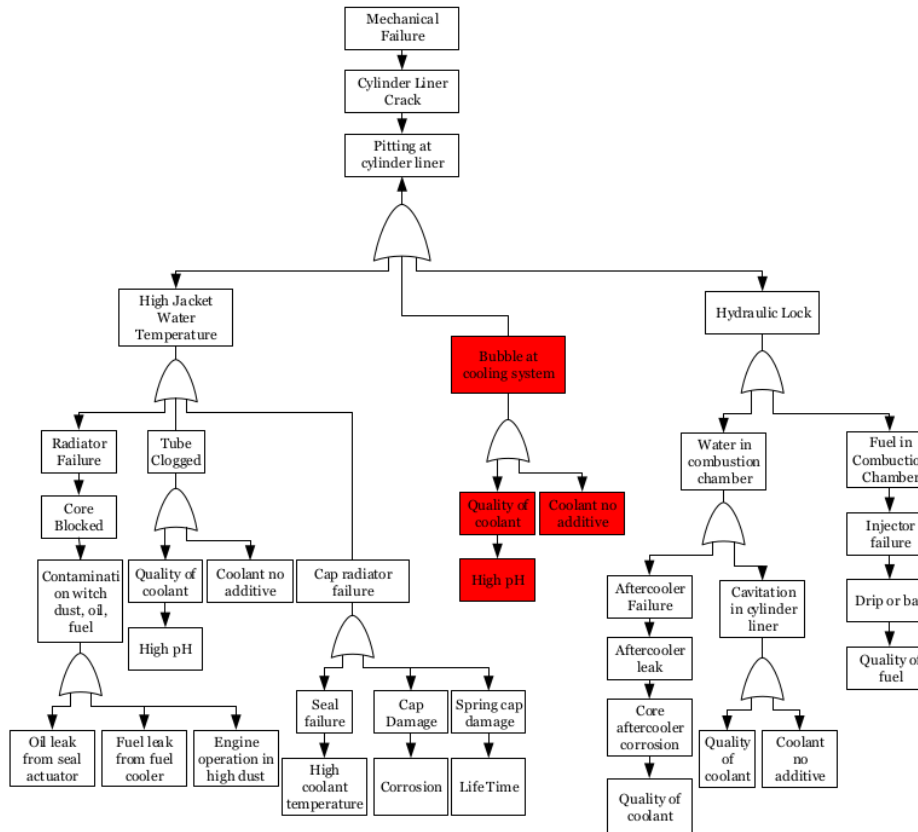
Figure 7. Fault tree analysis

From the analysis carried out using fault tree analysis, several parts cause pitting on the liner resulting in cylinder liner cracking, according to the explanation in Figure 7.

- High radiator water temperature caused by radiator damage, especially radiator core covered with dust, oil, and diesel contamination, so the water flowing through the radiator is hot. Then it has flowed back to the engine in hot conditions, the hot radiator water cannot absorb heat properly, and will cause damage to the components that are fed by the radiator water. As for the contamination of the radiator core against oil leakage caused by damage to the actuator seal, and contamination of dust and diesel, there is damage to the fuel cooler, and the engine operates in an area with high dust.

- Blocked radiator tubes: Silica deposits in the cooling system will affect the heat distribution to the cooling system. If the additive concentration exceeds 60% it will affect the ability of the water as a coolant and will produce silica deposits. This silica deposit will reduce the diameter of the oil cooler tube. Excessive mineral content in water can cause damage to engine components, due to the inhibition of heat transfer[14]. Coolant radiators that do not use additives will affect the boiling point of the coolant and make it easier for air bubbles to form in the cooling system.

- The relationship with high radiator water temperature, as stated in point A (2), is related to damage to the radiator core.
- Broken Radiator Cap [7][15]: Leaking water on the radiator cap can cause reduced pressure and coolant, the air in the system will cause bubbles or aeration and will affect the ability of the water pump.

- Radiator water quality that is not per the specifications used, where the excessive mineral content in the water can cause damage to the engine due to inhibited heat transfer [16]. In this case, it will affect the boiling point of the radiator water which can cause air bubbles [17].
- Air bubbles bursting at hot spots in the cylinder liner area will result in corrosion wear [18]. Air bubbles in the cooling system can form because the radiator water does not use additives [19][20].

The hydraulic lock that occurs is due to the presence of liquid fluid (diesel and water) in the combustion chamber. This event occurs when the unit is on standby (not operating), and when it is about to be operated the engine cannot crank or start, and if forced it will result in broken connecting rods and damage to other engine components.

- Damage to the aftercooler (air cooler) due to corrosion of aftercooler components. Corrosion that occurs is due to the quality of radiator water that does not use additives.
- Pitting on the cylinder liner can result in liquid fluid being in the combustion chamber because the pitting depth is more than 2 mm.
