**How to Investigate and Analyze
the Components of a Generator Engine
and Machine Industry**

This book presents how to investigate and analyze the components of a generator engine and machine industry. The discussion presented starts from the problems that occurred, a review of failures, the strategies used to the output of an investigation.

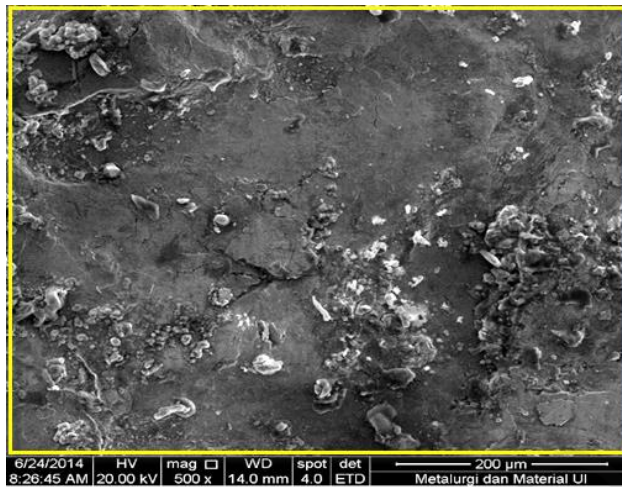
Figure 3. SEM material discoloration with a magnification of 500x

SEM analysis was carried out on a surface that had discoloration. SEM tests were intended to determine the cause of discoloration on the connecting rod surface [7], [8], [9]. The surface shows the formation of an iron-oxide structure, namely the formation of morphology following the results of the SEM test are presented in Figure 3.

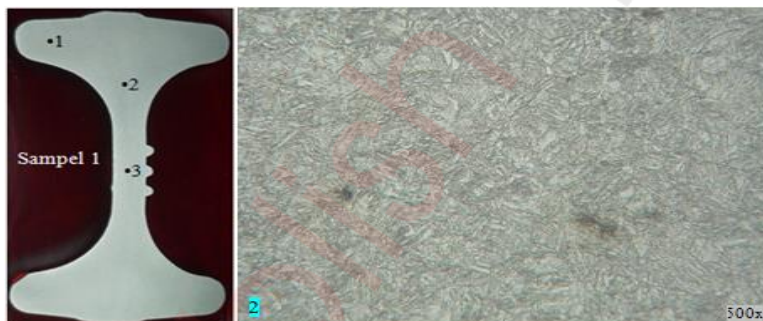
Figure 6. Microstructure of location 2

Based on Figure 6, it can be seen that the microstructure is the same as that of sample 1, namely the microstructure in the form of tempered martensite with sulfide impurities and the metal is still in normal condition.

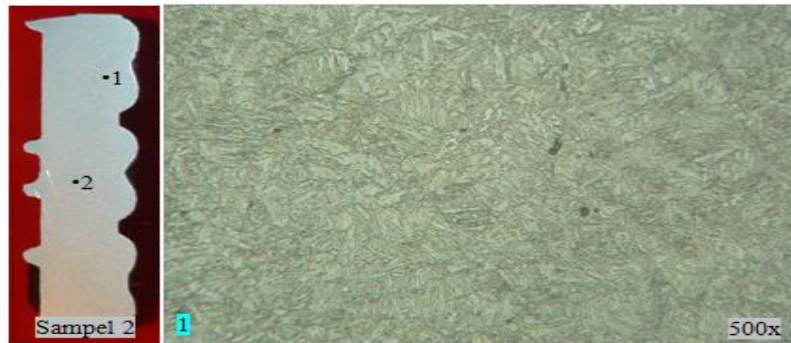
Figure 7. Microstructure of location 1

Based on Figure 7, the microstructure of sample 1, the results of the microstructural analysis can be obtained information, namely: a) the temperature increase that occurs in the #10-cylinder liner on the engine does not change the microstructure of the connecting rod material. After conducting a microstructure test, the temperature was 200°C, this condition was not able to change the hardness, strength and structure of the connecting rod. Based on the ASM Handbook [23] that alloy steel will experience temper embrittlement or temper brittleness at temperatures between 300-600°C where the steel will experience an increase in hardness and a decrease in ductility. b) the type of heat transfer that occurs which causes color changes in the connecting rod due to radiation.

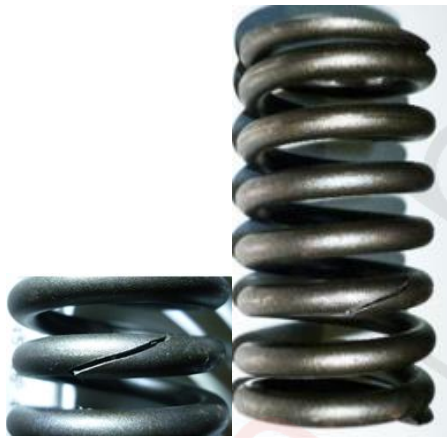
Figure 15. Photo macro injector

The visual inspection of the spiral spring injector, A wire diameter \varnothing 7.0 mm and \varnothing 48 mm spring circumference suffered a fracture in the first circle [17].

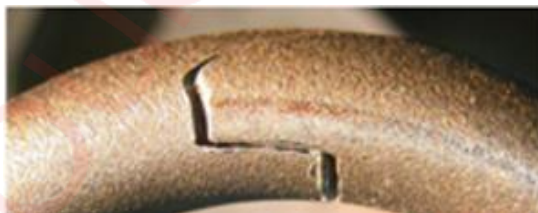
Figure 16. Broken shape of the injector spring

The macro photo in **Figure 16** shows the injector springs. The center point of the fracture is a load-bearing area and is the center of high stress concentration. It can be seen from the circumference of the fracture that there are crush defects between springs and spring defects. Spiral loop spring 3 is the initial fault that occurred first.

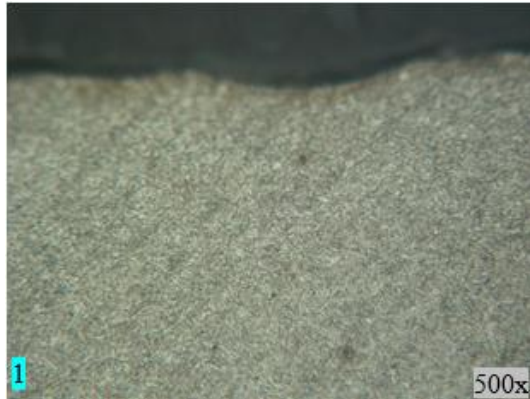
Figure 19. Microstructure of tampered martensite

Figure 19 shows the microstructure of the spring test sample 1 in the form of tempered martensite. Tempered Martensite occurs when the metal is heated to below a critical temperature after the hardening process. The crushing process will affect the steel mechanics on tensile strength.

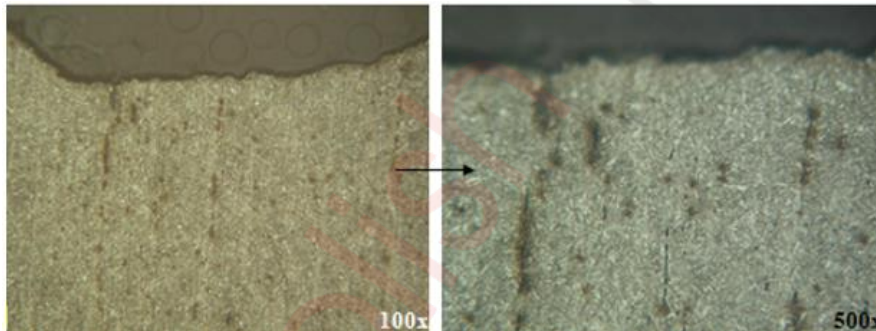
Figure 20. Magnification of 100x and 500x

Figure 20, with 500x magnification, contains secondary cracks due to dynamic load. Secondary crack is caused when a break occurs and is not the cause of the damage. At 500x magnification, inclusions were found on the subsurface [19].

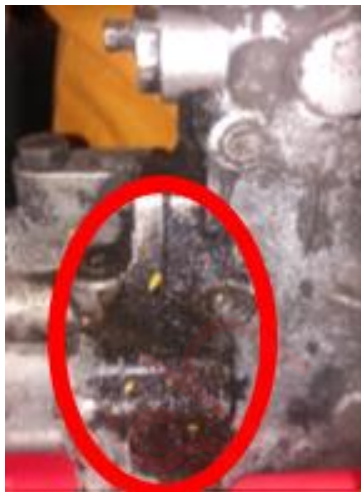
Figure 24. Fuel leak.

Figure 23 explained that there were indications of a fuel leak in the fuel supply pump component. The seepage that occurs will have an impact on the pump when it is used. Contamination will also cause external particles to enter the fuel supply pump and damage other components. In parts that experience leaks, this can be caused by damage to the O ring seal, the formation of grooves, or contamination during installation [23].

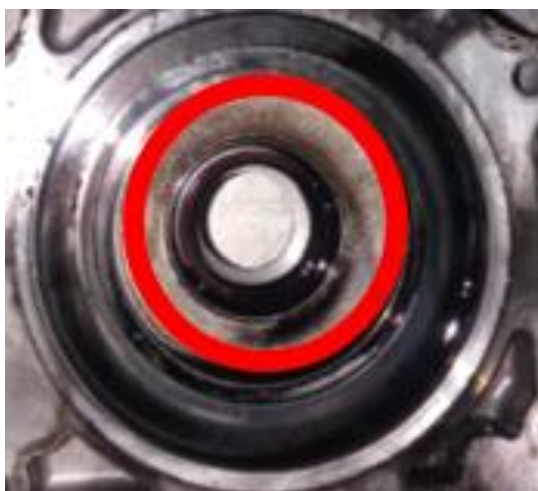
Figure 27. Damaged fuel pump parts.

It is known that the fuel supply pump is damaged. The seal and lip seal on the supply pump are worn. There are several factors that cause wear, including seal installation that is not tight or even not in accordance with Figure 24. This wear can also be caused by the age of the components.

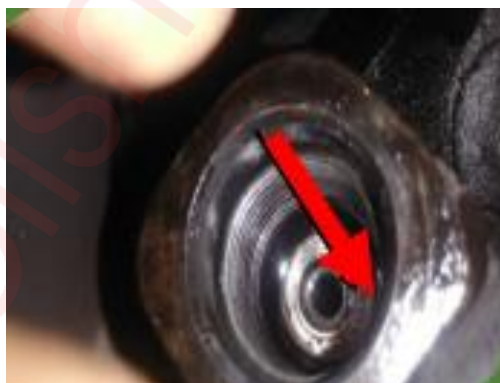
Figure 28. The delivery valve hole contains particles.

There are many factors that cause particles in the delivery valve hole, 1) fuel quality, 2) fuel filtration quality, 3) contamination during component reconditioning. The impact of this contamination will affect pump performance and shorten component life.

The hole in the Delivery Valve has particles stuck to it. This occurs due to poor cleanliness of the Hole Delivery Valve as explained in Figure 28.

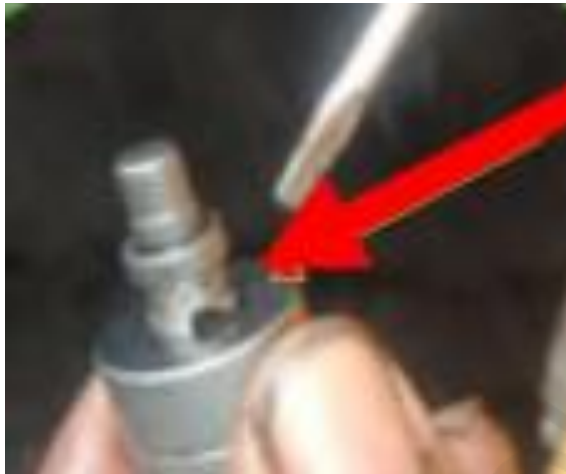
Figure 29. Stopper delivery valve

The Stopper Delivery Valve is experiencing wear in Figure 29. This occurs because there is dirt on the Delivery Valve, causing the parts that rub together to wear more quickly.

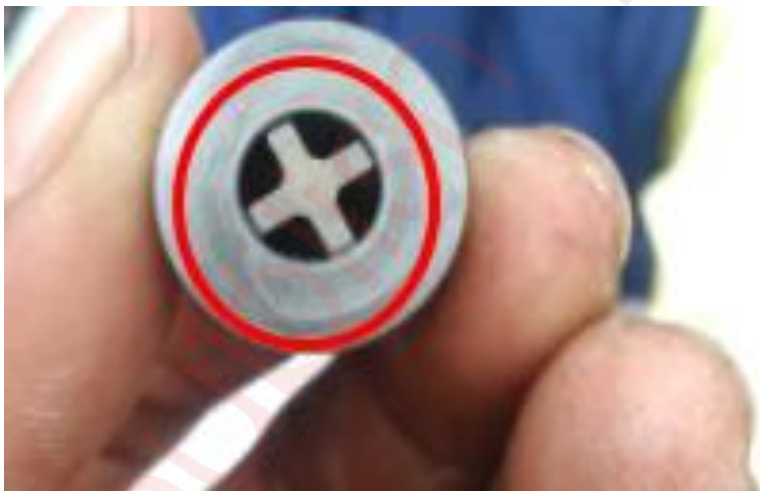
Figure 30. Valve assembly

Figure 30 valve Assy experienced chipping. This happens because there are dirty particles that are also compressed. Chipping falls into the fatigue wear category. This is due to surface interactions where the surface experiences repeated loads and leads to the formation of micro cracks. Microcracks coalesce and cause peeling of the material.

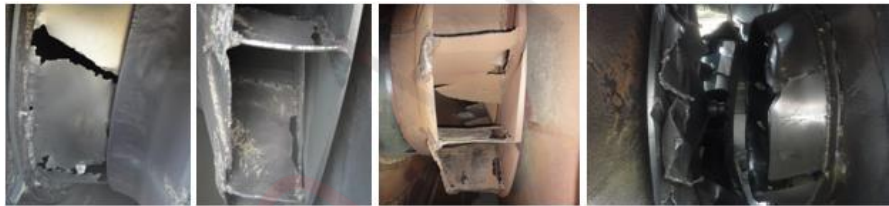
Figure 34. Faulty IDF fan blade and cone

There were 61% of shutdowns that occurred due to 8 times the damage to the IDF, equivalent to a loss of operating hours of 911 hours. Failure mode in IDF is the occurrence of perforated blade plates and cones due to abrasion by fly ash, resulting in a decrease in exhaust gas suction capacity by fans, and vibration which causes damage to bearings and v-belts. **Figure 34** shows the types of damage that occurred to fan blades and cones that occurred during 2013.

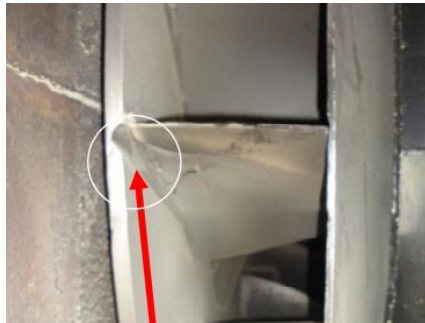
Figure 37a. IDF abrasion blade

The types of damage caused by combustion dust that is not captured are abrasion and perforation. In **Figure 37**, 2 types of damage occur to the fan blade. The perforation on the blade surface occurs after the abrasive content contained in the flue gas causes abrasion on the fan blade surface.

Abrasion occurs because fly ash containing 12.6-14.2% Fe_2O_3 collides with the fan blade surface. Also, fly ash also does not undergo a reduction process due to a non-functioning ESP.

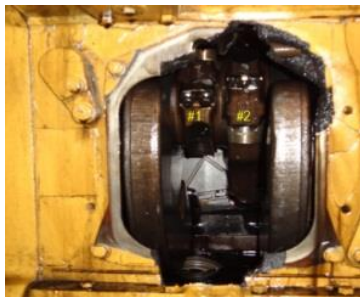
Figure 39. Condition of engine block and crankcase cover

Operators who are monitoring the operating unit and the unit next to them hear a rough sound (knocking) and then check the sound source. Shortly thereafter the unit experiences over vibrations accompanied by rough sound (knocking), then the operator performs an emergency stop on the unit. After the engine stopped the operator did a visual check and found damage to the engine block, liner, broken piston rod, broken crankcase cover and some components were out of position.

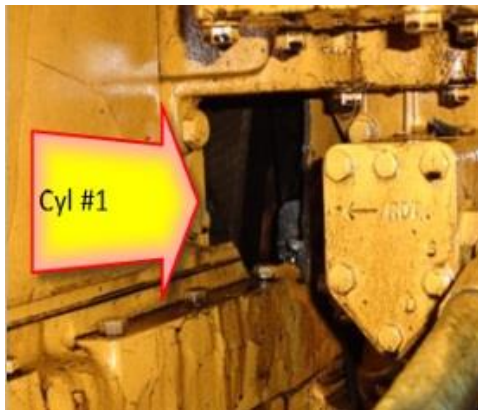
Figure 41. Broken cylinder engine block

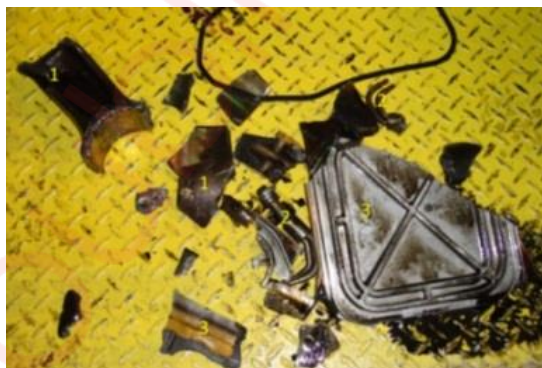
Figure 42. Broken engine components

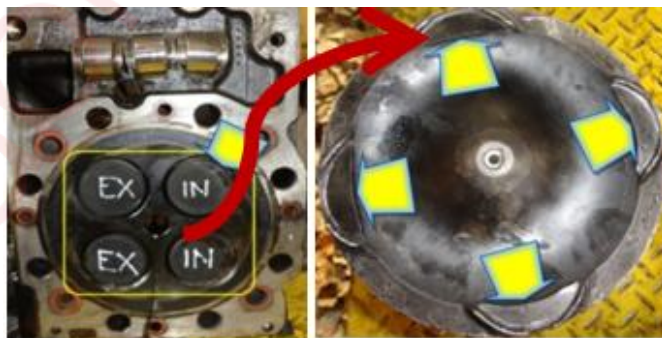
Figure 44. Top crown piston damage

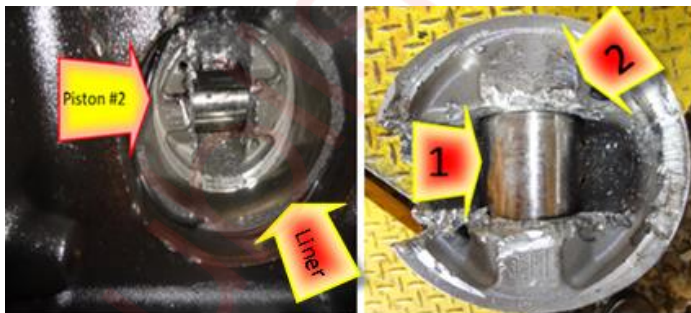
Figure 46. Broken Pistons and Liners

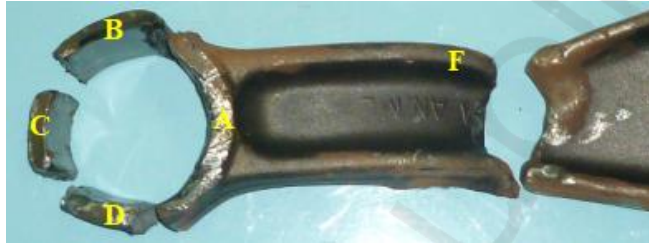
Figure 47. Connecting rod faults

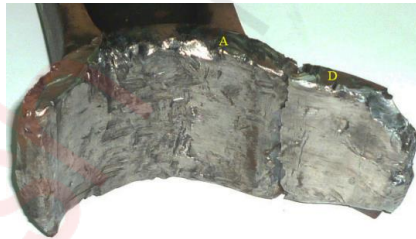
Figure 48. Fault in position A & D.

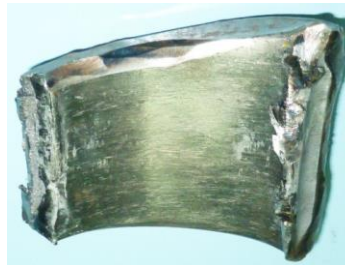
Figure 49. Small end (rod eye) fracture shape in position B

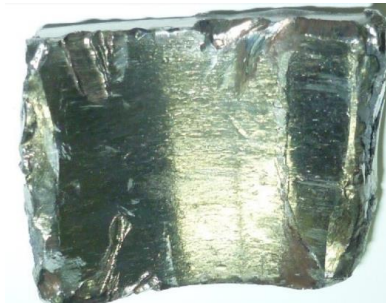
Figure 50. Fault position of C small end (rod eye).

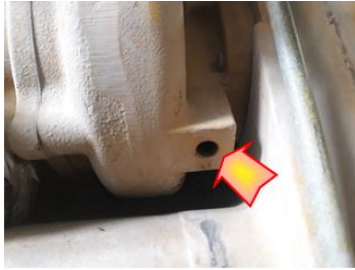
Figure 56. Water pump leak

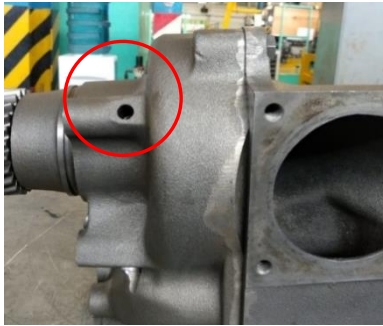
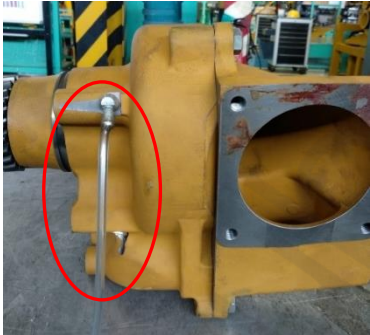
There is no barrier preventing foreign objects from getting inside the water pump indication hole.	There is a hose attached to shield the water pump indication hole from extraneous particles.

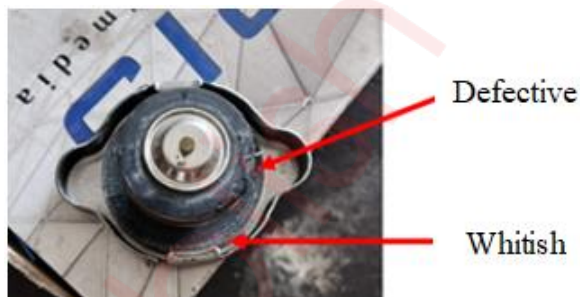
Figure 64. Damaged radiator cap seal and whitish color

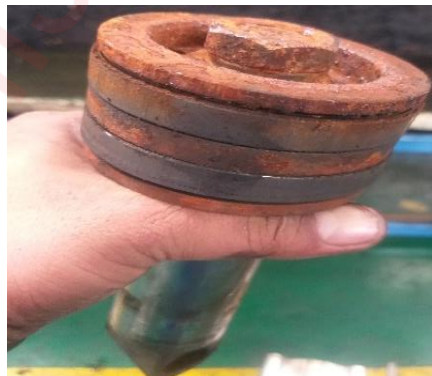
Figure 68. Pneumatic piston corrosion

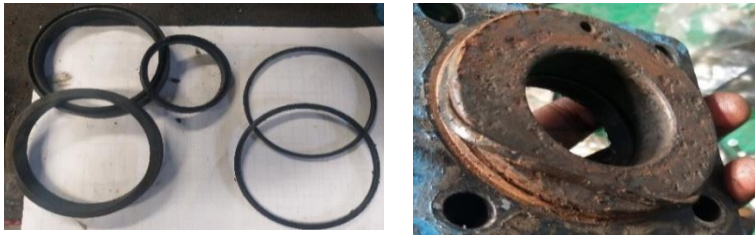
Figure 69. Damaged pneumatic seal

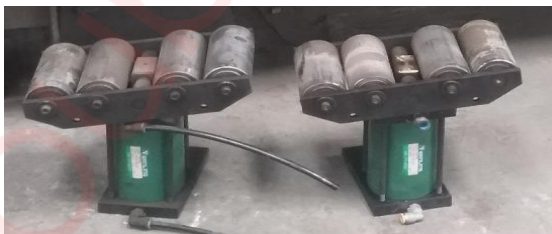
Figure 70. Damaged pneumatic
