Analysis of Engine Piston Damage to the Generator Set Using the Fishbone Analysis Method

Abstract. The generator set unit operating at PLTD Leung Bata-Aceh suffered damage to the piston component, which initially indicated thick white smoke coming out of the breather. The purpose of this study was to determine the root cause of piston damage. The method in this study using fishbone analysis. Based on the research results, the damage to the piston top was caused by the imperfect angle of the injector, so that the injector spray widened on the outer side of the piston crown top, causing the piston surface to be damaged on the edge. Corrective steps so that the same incident does not occur again, the injectors must be tested before use, they must be tested, to determine the performance of the injectors used.

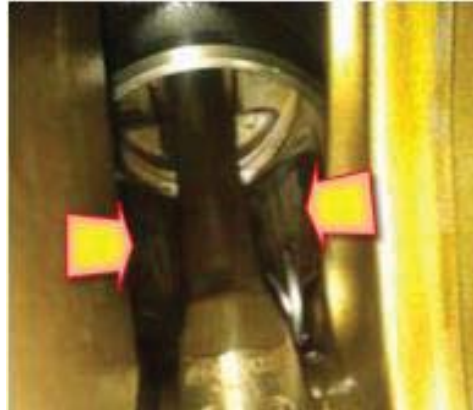
FIGURE 1. Fuel leakage from the liner and piston.

In Figure 1, the liner wall flows scratches caused by friction with the piston that is damaged. Scratches that occur cause the liner not to be used again and the damage to the liner is the result, not the cause. Figure 1 scratch on the inner liner was found during a fault investigation component.

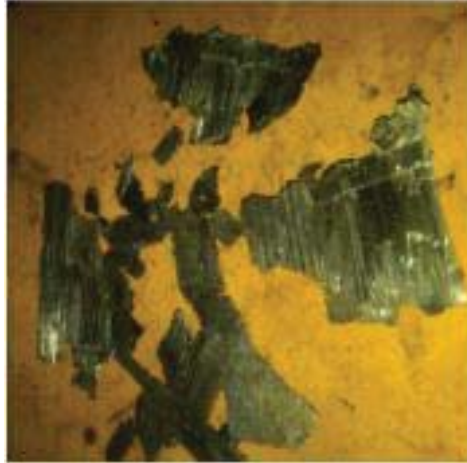
FIGURE 2. Flakes of piston material.

Whereas Figure 2 shows the piston debris attached to the liner wall, discovered during a fault investigation of the generator set. The piston material attached to the liner wall is caused by the piston working at high temperatures. The piston moves in the process of experiencing stress, temperature, pressure which often occurs due to thermal and mechanical fatigue [6]. Figure 2 piston material debris was found during the investigation.

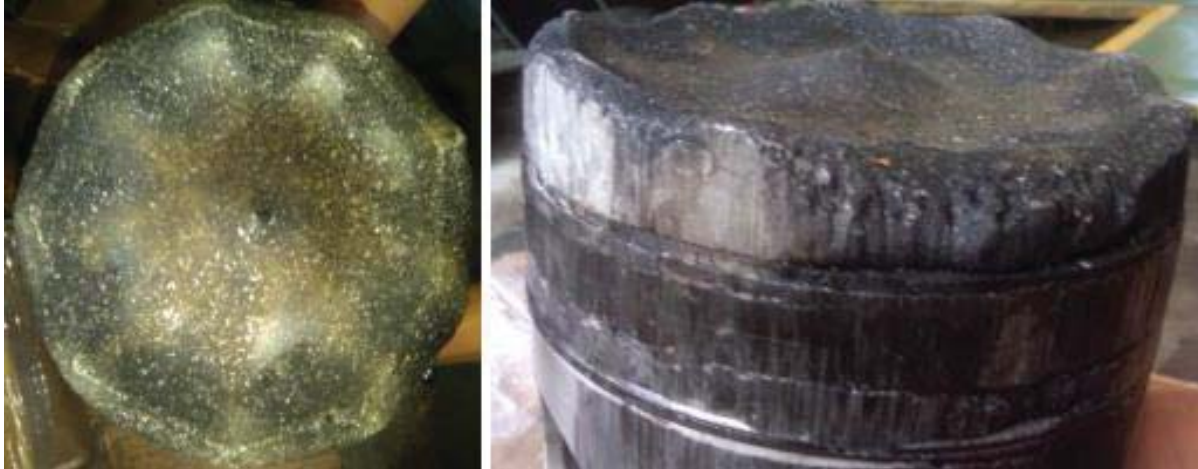
FIGURE 4. Top melting piston crown on cylinder # 12.

Damage to piston skirt #12 experienced the same as piston # 5. Self-explanatory on the top crown the piston spray injector is abnormal. If this is left for a long time then the condition of the #12 piston will have a shape similar to that of cylinder #5 [5].

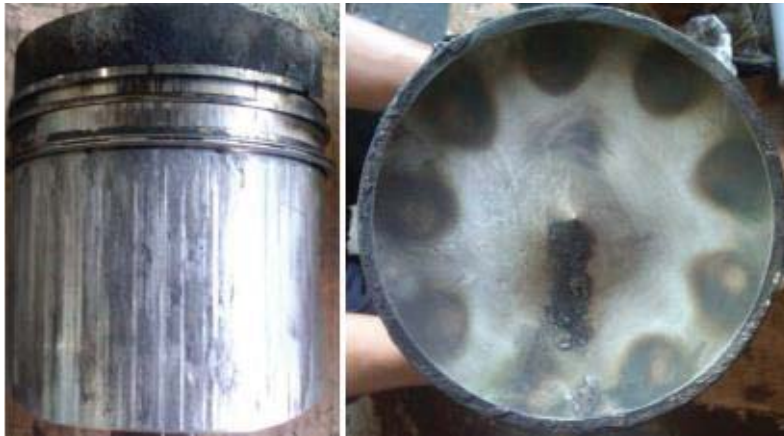
FIGURE 5. Spray injector on piston-cylinder #5

In Figure 5, it is explained that the high scratches piston wall where the piston works at high temperature so that the piston wall is melting and the town crown piston is indicated as a black discoloration on the side that gets the spray from the injector (right photo), ash on the town crown piston is caused by the abnormal angle at the injector [10] . Changes in the thermal expansion coefficient for the alloy in the raw state and after heat treatment and the piston made of the new composite material before the motor test and after this test [11] . As for the piston components that are used using aluminum, it is adjusted to the diesel engine serial number from the manufacturer.

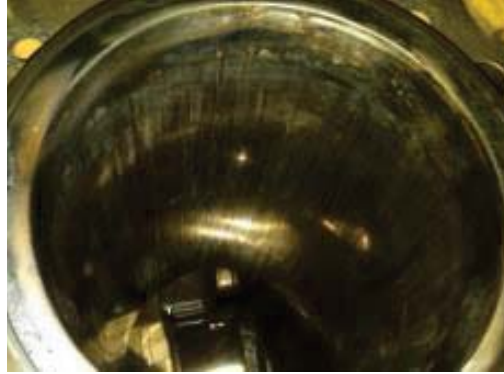
FIGURE 6. Wall liners high scratches

Heavy scratches on the liner walls due to the tow crown piston melting and closing the piston ring seat so that it contacts with the liner (scuffing). Measurement of the secondary motion of each piston was carried out to analyze piston friction, and the following findings were obtained. Cast iron pistons exhibit limited lubrication at die center over-compression (TDC). This is probably due to the larger piston tilt angle due to the greater piston clearance. Steel pistons exhibit hydrodynamic lubrication conditions at TDC and BDC through each cycle, due to good oil supply [12] .

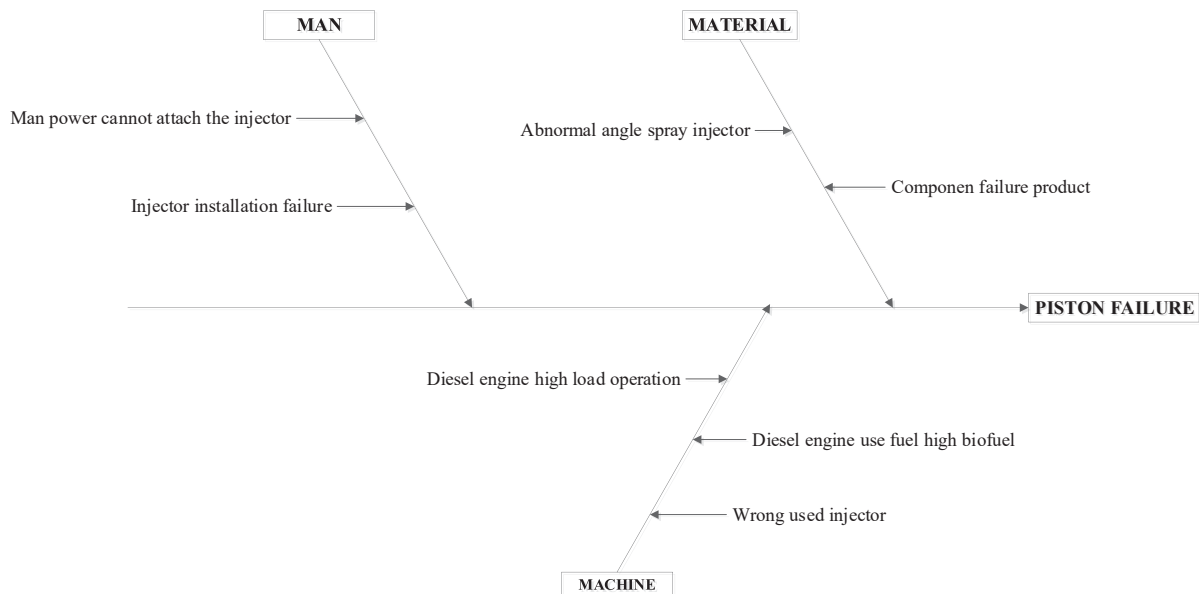
FIGURE 7. Fishbone analysis

The analysis was carried out using fishbone analysis where in this study there were 4 categories in determining the root cause of piston damage (Top piston crown).

At the time of installing the injector, the technician failed to install it, and the tip of the injector collided with the engine component. Then it was wrongly installed, where this condition was caused by the knowledge of the technician who did not understand the injector installation process.

Angle spray injector is damaged due to the design of the manufacturer because it does not match the engine type or product failure.

Piston damage caused by high operating load or overload is not identified for piston damage, then the damage caused by fuel containing biodiesel is not indicated. Meanwhile, the error in using the injector is not indicated [7]. The delay in the execution of the engine overhaul will affect the performance of engine components. In determining the unit's overhaul work there is no maintenance strategy, so the overhaul work is based on the unit's condition.

Trending in addition to 150 liters of engine oil starting high school: 2,784-2,922, during the unit operating 138 hours, at the hour meter 2,922 a blowby occurred in the operating unit, where the damage was caused by damage to the piston components. Based on the fishbone analysis, the damage was caused by an abnormality in the angle of the injector.
