**How to Investigate and Analyze
the Components of a Generator Engine
and Machine Industry**

This book presents how to investigate and analyze the components of a generator engine and machine industry. The discussion presented starts from the problems that occurred, a review of failures, the strategies used to the output of an investigation.

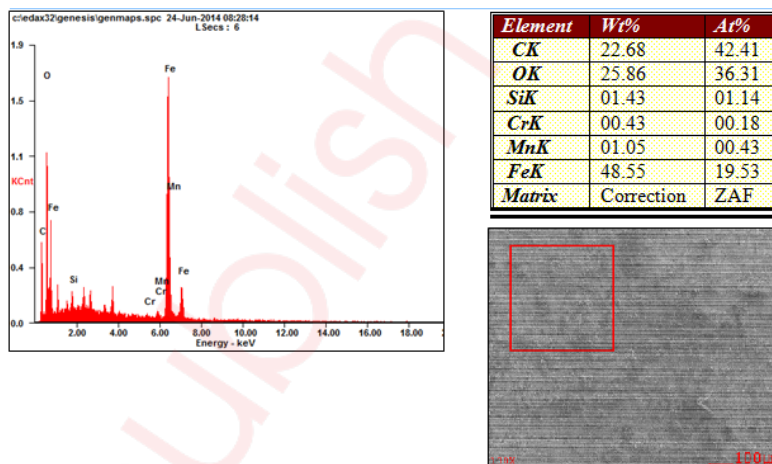
Figure 4. EDX examination of discolored connecting rod material in the shank

EDX analysis in **Figure 4** which shows the high levels of iron (Fe) and oxygen (O) confirms that the formation of iron-oxide on the metal surface is due to the influence of heat

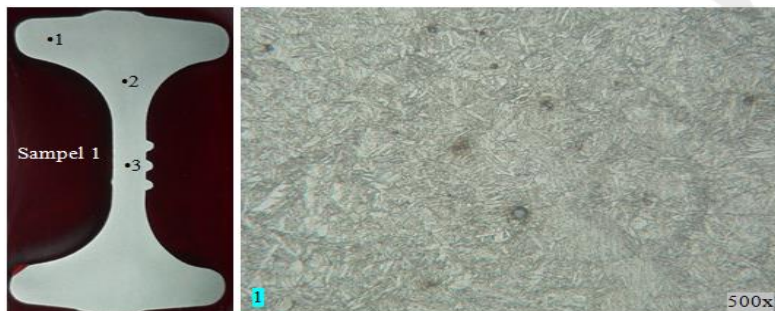
Figure 5. Microstructure of location 1

sample 1, namely the discolored cross-section of the connecting rod, it is seen that there is no difference between the three and they are still in normal condition. Based on Figure 5 and Figure 6, the structure is composed of tempered martensite which both have sulfide impurities [8]. The impurity sulfide does not affect the color change of the connecting rod. Then the impurity sulfide has no relationship with the occurrence of color changes.

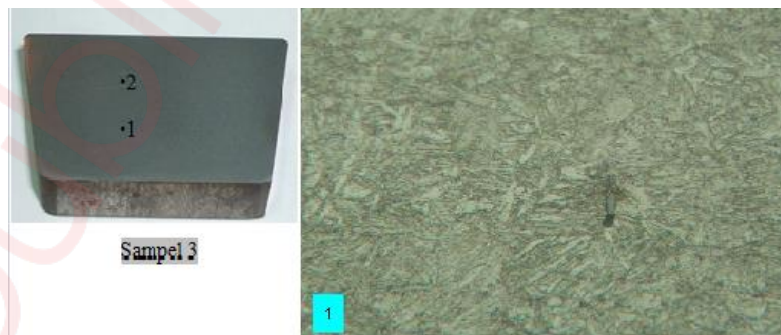
Figure 8. Location 1

Scanning Electron Microscopy (SEM) analysis shows that the connecting rod material changes color due to increased heat, namely the formation of iron oxide such as lepidocrocite (γ -FeOOH) morphology. This occurs from the level of heat received by the connecting rod, which is around 200°C. The color change that occurs in the connecting rod predominantly occurs by radiation, namely heat transfer from the liner wall to the connecting rod due to exhaust gas leaks into the engine crankcase. Where there has been damage to the piston ring on cylinder #10 which causes the piston ring to overlap and cannot expand, resulting in a compression leak in the combustion chamber. The impact of exhaust gas compression leaks will flow to the engine crankcase. The movement of the connecting rod which cannot go up and down with the working stroke causes the connecting rod to experience tensile and compressive forces. The follow-up to this examination is to carry out testing using CATIA software.

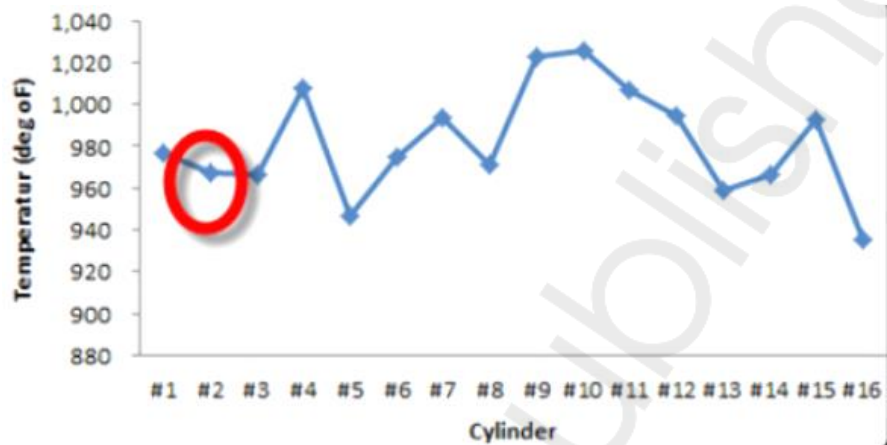
Figure 10. Trending exhaust temperature.

In maintenance, the failures of diesel engine components are found so many. To find out the failure analysis of a component, further analysis must be carried out in order to reduce repair costs [13]. In the 30 minutes before the exhaust manifold was damaged or smoldering (glowing) and then an emergency trip (normal stop) was carried out by the operator. At the moment the injector spiral spring [14] broken, fuel pressure in the injector drops slowly, and the duration of spraying fuel will be longer, because the pressure inside the injector drops slowly, resulting in over-fueling and glowing [15]. Before the diesel engine malfunction occurred, the water jacket temperature, oil pressure, oil temperature, exhaust gas temperature occurred [16], described in **Figure 10** under normal conditions there is no significant increase when the damage occurs.

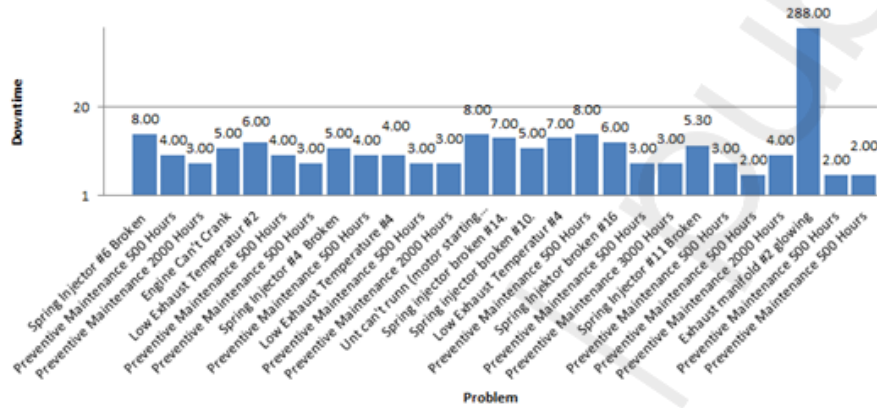
Figure 12. Downtime preventive maintenance and breakdown maintenance

Injector repair requires fast time for the unit to operate immediately and is not subject to akWH penalty. Usually, repairs take a long time because the stock of parts is not available at the location or the dealer. Figure 12 shows the downtime of the unit failure and preventive maintenance of the generator set making the test sample. From the figure, it can be seen that the damage to the injector causes the longest downtime. This is due to the availability of spare parts.

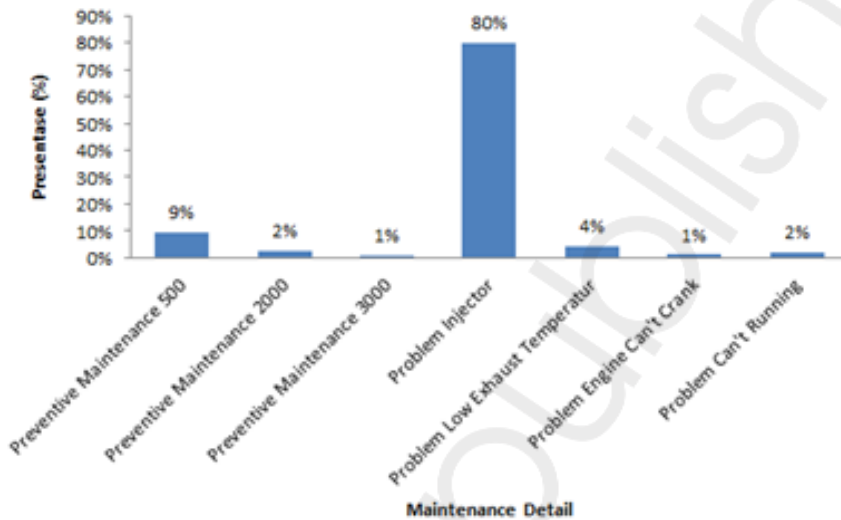
Figure 13. Graph of total injector failure downtime

Based on historical observations of data after Pareto downtime, it is clear that the damage to the injector components is quite high compared to the damage to other components, the damage to the injectors accounts for up to 80% of the damage.

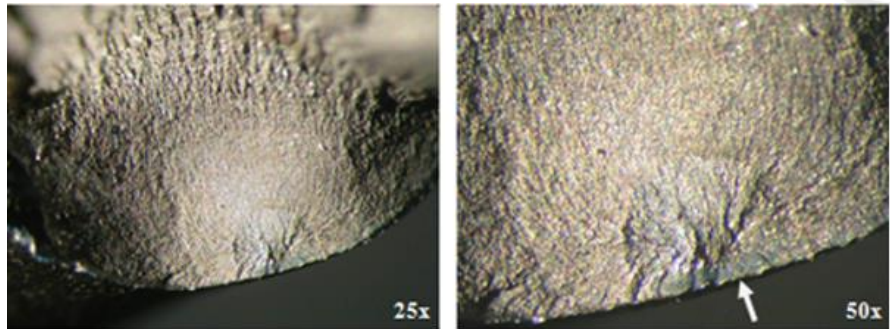
Figure 17. Benchmark of injector spring fault

Figure 17 describes the benchmark that occurs in spiral springs showing the benchmark from point A-C. In a reference from “Daniel P. Dennis, Ph.D., PE, How to Organize And Run a Failure Investigation, ASM International Material Park, Ohio 44073-0002, www.asminternational.org”, that the indication of the benchmark is a form of a fatigue fracture in injector spring [20].

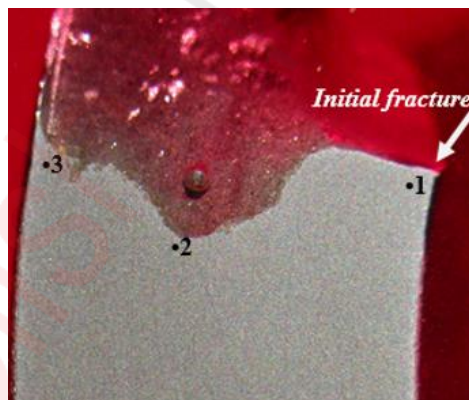
Figure 18. Position of Microstructure

Metallographic testing 1 microstructure in the form of ferrite and there are inclusions or sulfides (long black spots)[18] and Metallographic samples of the cut lengthwise or splitting the initial fracture area and the location of the microstructure location in the image.

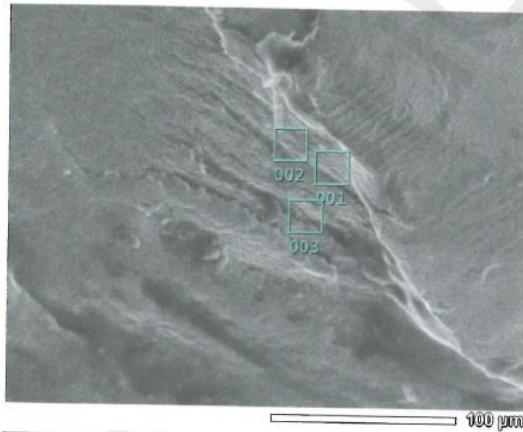
Figure 21. SEM EDX position [22]

Element	Elemental Content (mass%)		
	Area 1	Area 2	Area 3
C	13,73	18,06	15,52
O	11,75	20,16	10,47
Si	1,8	1,87	1,81
Cr	0,84	0,84	0,86
Fe	71,88	58,97	71,33

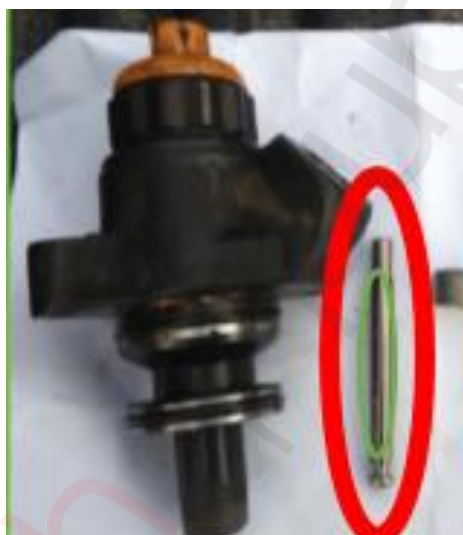
Figure 31. Plunger delivery valve

Figure 31 plunger delivery valve experiences wear when moving up and down in the plunger chamber due to dirt in the fuel used. This wear occurs because two materials rub against each other and in between there are debris or dirt carried by the fuel [28].

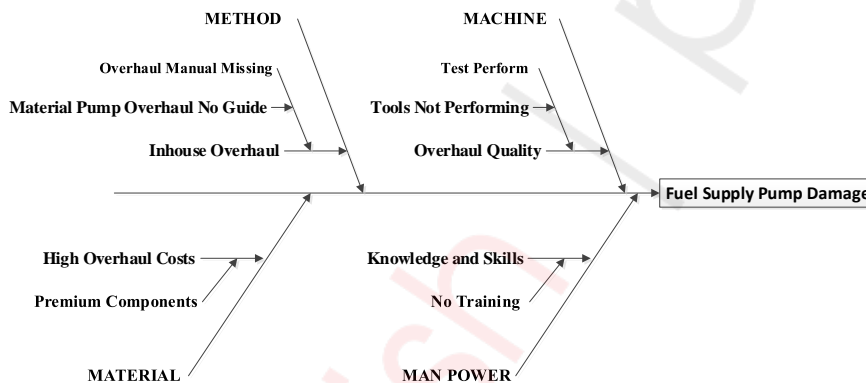
Figure 32. Fishbone Diagram

From the **fishbone analysis** in Figure 32, it can be seen that there are many factors that influence the quality of the Fuel Supply Pump reconditioning process. Next, improvements need to be made to improve the component reconditioning process.

Material: Overhauling the unit requires quite a large amount of money, every time you overhaul the fuel supply pump you have to buy a premium one from the manufacturer. Because some component parts such as the inner part and the fuel supply pump are almost the same.

Man Power: Manpower to carry out fuel supply repairs has never received training. So manpower is not sure if they are asked to make repairs.

From the analysis carried out based on the facts of the damaged components and the fishbone diagram, the fuel leak at the fuel supply pump was contaminated with material, causing a leak when the unit was operated. This analysis is based on **Figure 24** and **Figure 26**.

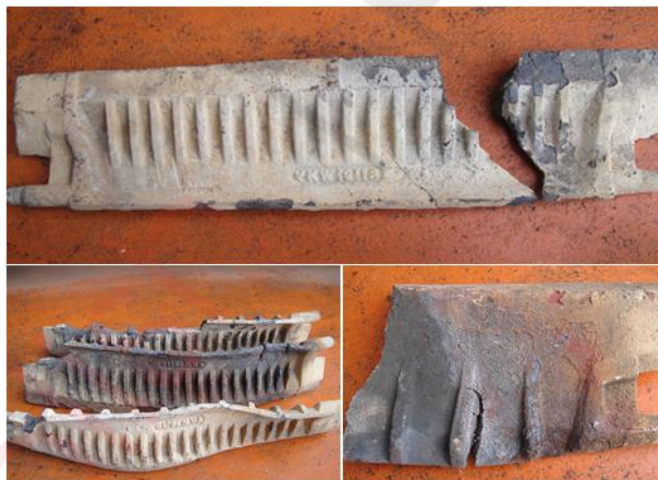
Figure 35. Failed grade bar

Machine: The stoker boiler with a traveling fire grate used at PLTU Nagan Raya is under the specifications of the coal (lignite) used as fuel. This type of boiler can accommodate the combustion of high to low-quality coal. However, coal is used with an ash content of 8.23% [35], which is lower than required, which is between 10-15%, causing the ash layer to form on the grate to be less than 5cm. This caused the damage to the grate bar with an average occurrence of 40 pcs per month **Figure 35** during 2013. This damage did not cause the operation of the generating unit to stop, because grate bar replacement could be carried out while the boiler was operating.

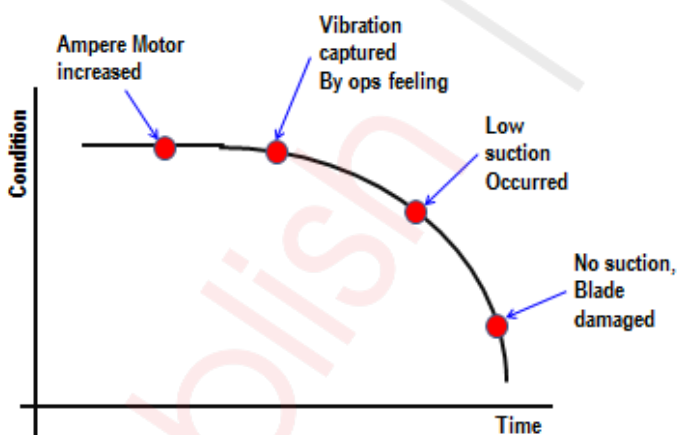
Figure 36. IDF deterioration curve

IDF damage begins with an increase in amperage on the electric motor or the motor experiences an overload. This condition was discovered during routine inspections. Damage occurs when the rated ampere is 470 Ampere to 490 Ampere either constantly or hunting. This increase is the result of abrasion on the fan blade so that the blade rotation against the shaft becomes unbalanced. Increasing the ampere in the electric motor will develop a vibration that can be felt by the operator. If the vibrations that occur are not followed up, the IDF's performance will decrease until physical damage occurs to the fan blade and the IDF casing. IDF final failure will also damage the bearing, bearing housing, and v-belt. The IDF damage curve is shown in **Figure 36**.

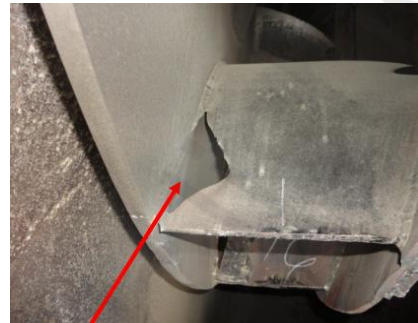
Figure 37b. IDF perforated blade

The types of damage caused by combustion dust that is not captured are abrasion and perforation. In **Figure 37**, 2 types of damage occur to the fan blade. The perforation on the blade surface occurs after the abrasive content contained in the flue gas causes abrasion on the fan blade surface.

Abrasion occurs because fly ash containing 12.6-14.2% Fe_2O_3 collides with the fan blade surface. Also, fly ash also does not undergo a reduction process due to a non-functioning ESP.

The coal specification used is lignite with Fe_2O_3 content which has met the chemical composition limit (4-15%). 8.23% of ash content does not cause damage to the IDF but the grate bar. IDF damage occurs due to a malfunction of the ESP which causes the abrasive material (Fe_2O_3) in the flue gas to flow towards the IDF and the fan blade is in direct contact with the abrasive material, resulting in abrasion and perforation on the IDF fan blade.

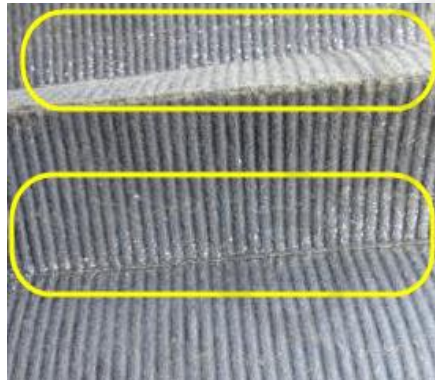
Figure 43. Large particles at oil filter

To identify the particles that are in the oil filter of the engine components, checking the oil filter is carried out. Because the oil filter functions to filter particles under 2 microns, if the particles are smaller than 2 microns, the particles will be carried to the lubrication system.

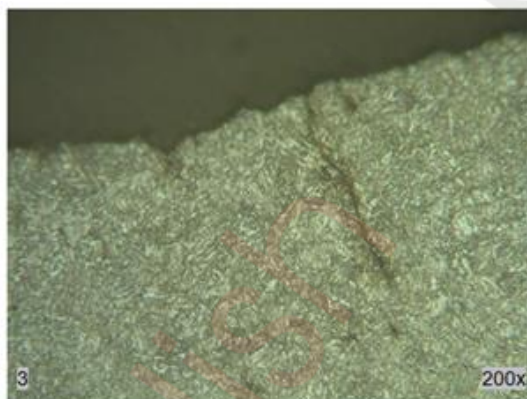
Figure 51. Micro structure of the rod eye fracture

The microlocation structure of 3 fracture samples 2 in the fault area is bainite-ferrite and cracks occur due to impact loads.

When the unit operates the bushing spins and starts to exit the bore. A little part of the bushing is released into debris and this splinter is found in the oil pan. The remaining bushings that are still inside the bore are overloaded so that damage occurs to the rod eye. The results of a visual examination showed that the damage began in the rod in the rod eye area. The occurrence of fatigue is caused by an enlarged bushing chamber due to wear or friction that is significant enough to the distance between the bushing and the surface of the

loose rod eye diameter. After cracking propagates large enough the cross section of the rest cannot withstand the load so that it occurs broken. When the piston rod is not in the piston pin and the piston rod is released and collides with the engine block. The failure was followed by a broken piston rod colliding with the engine block

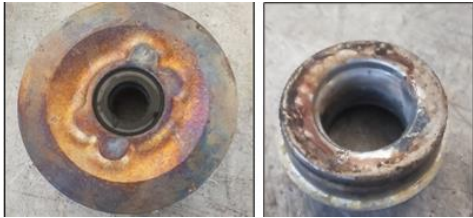
- a) Ceramic water seals sustain damage frequently due to their high susceptibility to dust contamination. When the water pump shaft spins, the wind speed from the radiator fan pushes dust or other particles into the indicator hole where they adhere to the seal and shaft gap, trapping the dust. This arrangement of the water pump on the engine's front side near the radiator fan creates this phenomenon is abrasive and wears down the ceramic seal's surface between the seal and shaft.

Because of deterioration, the ceramic water seal was unable to completely seal the water.
2

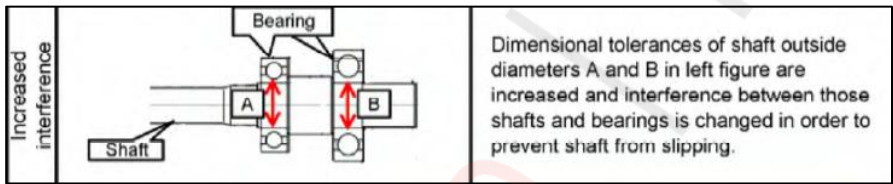
Figure 57. Bulletin for upgrading water pump components type SAA6D170e-5

- b) The water pump shaft bearing is damaged, this is due to looseness in the water pump shaft and the inner side of the bearing, as explained in the round sign in Figure 57. The picture explains that the cause of the bearing not sitting perfectly and causing it to slip and rotate is that the bearing is not on the axis of symmetry and the tightness between the bearing and shaft of the water pump is small [20].

There is no barrier preventing foreign objects from getting inside the water pump indication hole.	There is a hose attached to shield the water pump indication hole from extraneous particles.

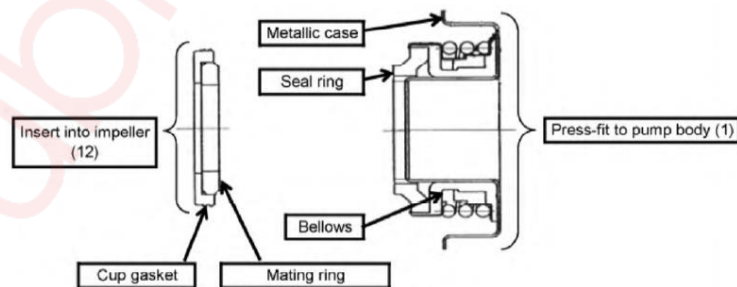
Figure 58. Details of the water pump ceramic baffle

- c) Because there is no lubrication at the point where the mating ring and shaft meet, the water pump shaft suffers anomalous wear between the ceramic seal and the water pump shaft. This state is seen in Figure 58.

DOT type lubricant is already used throughout the water pump component assembly process at the Narogong Plant Rebuild Center Workshop when the mating ring and cup gasket are installed on the impeller. The water pump shaft still sustains aberrant wear, nevertheless. During the analysis, a water-based lubricant (Water Soluble Lubricant) must be used when installing the mating ring and cup gasket onto the impeller. This is because an oil-based lubricant will evaporate when the seal is submerged in water because it is not a compound. Is varied or contains water. In the meantime, if you apply a water-based lubricant, it will keep lubricating the cup gasket and mating ring, preventing abnormal wear on the water pump shaft. Soap, or water soluble lubricant, is used during the installation of the mating ring and cup gasket [44]. This circumstance is displayed in Table 10.

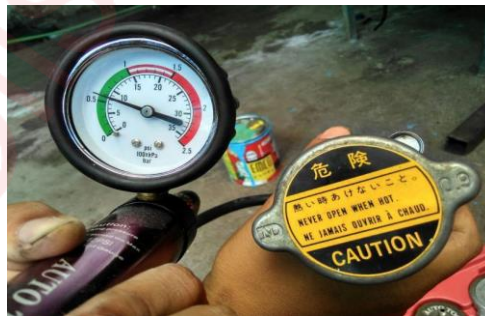
Figure 63. Radiator cap measurements

Radiator cap pressure measurement results [9] 0.6 kg/cm^2

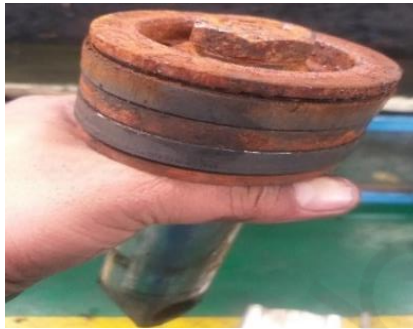
Figure 71. Pneumatic piston

The procedures for fixing pneumatic leaks are executed in accordance with **Figure 70**. Following the selection of the pneumatics that will be repaired, the pneumatics are disassembled and the source of the damage is examined. **Figure 71**. The water from the portable compressor caused the pneumatic piston to corrode and weather the seal, and the filter regulator (FR) was unable to reduce the water. To reduce the amount of water that enters the pneumatic system, this part—the Filter Regulator Lubricator—needs to be replaced (FRL).

Once the source of the damage has been identified, use type 320 coarse sandpaper and type 1000 finishing sandpaper to clean the corrosion-affected piston and pneumatic tube. To facilitate the installation of the pneumatic seal, the pneumatic components must first be sanded and then lubricated with ISO VG 32 oil. To facilitate installation, Figure 72's pneumatic components are lubricated with ISO VG 32 type oil. Figure 73 shows that the damaged seal is replaced with a new one after the pneumatic components have been cleaned.
